# **DIRIGO ENGINEERING**

## **RE: Evaluation of Skowhegan Fire Station**

## Preliminary Project Cost Estimate **Fire Station Rehabilitation** **Town of Skowhegan**

Re: Skowhegan Fire Station *Findings Report*.

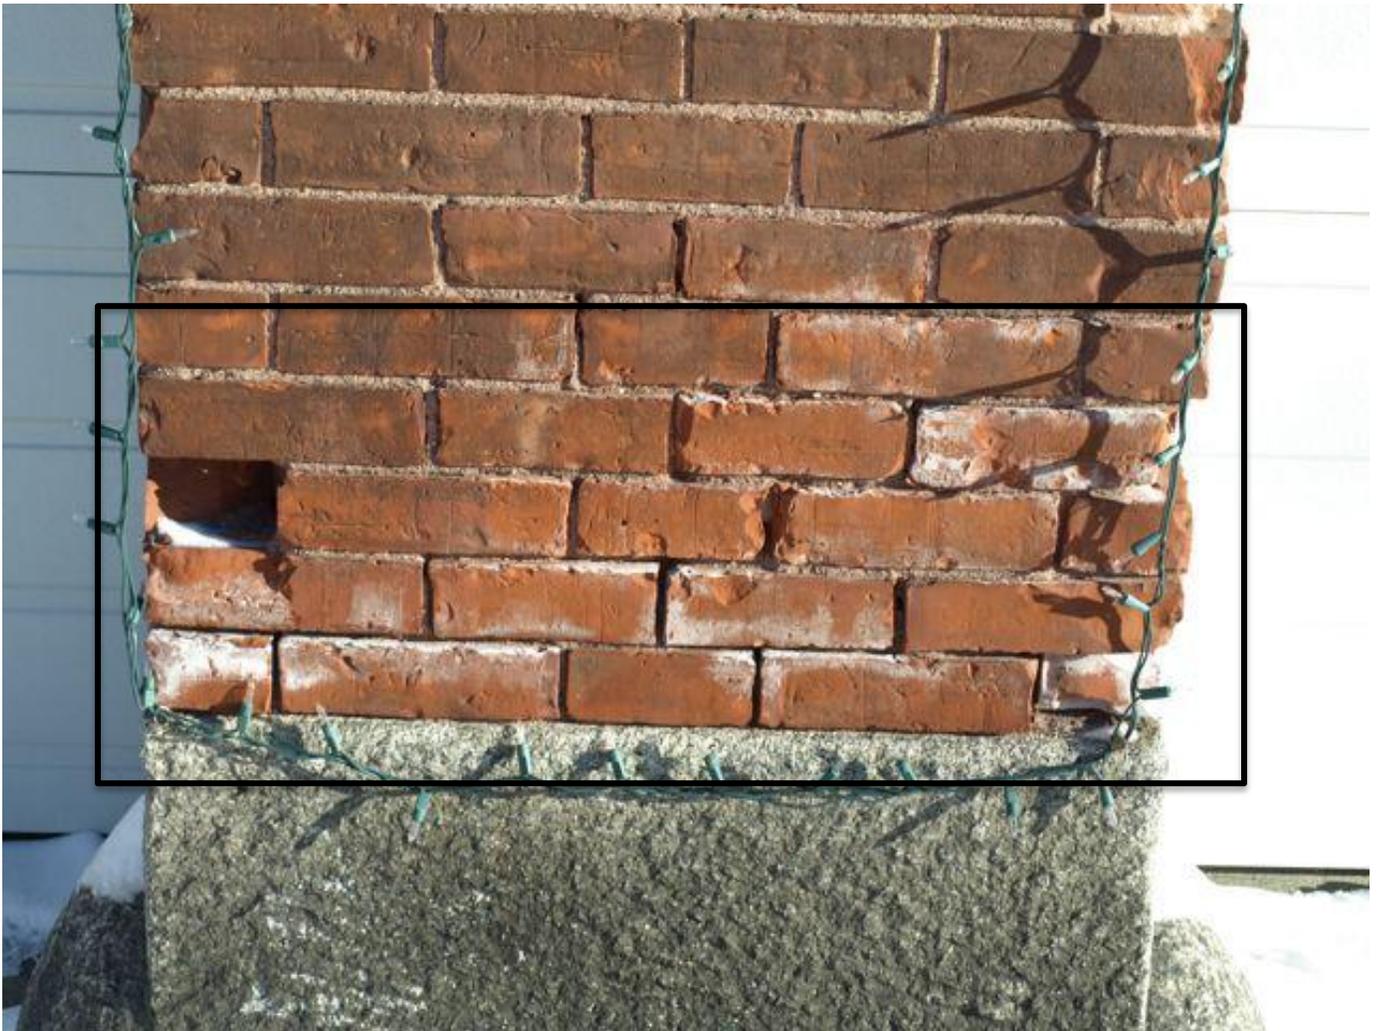
**Plate #1**

- The mortar joints within the brick assembly adjacent to the granite base course along the front of the building are deteriorated as evidenced in **Plate #1**. This is due to differential moisture absorption values between the clay brick masonry and the granite base. As moisture infiltrates the brick assembly during weather events, it migrates downward through capillary action allowing some reduction through normal evaporation. The moisture migration slows greatly when it comes in contact with the granite base course, thus creating a "head" or "reservoir" of moisture within the brick assembly. The rate of evaporation is far less than the moisture being added into the assembly thus creating a higher concentration of moisture against the granite base. Concentrations of moisture within a masonry assembly will produce moisture heads with enough hydrostatic pressure to continue the wetting process. Along the eastern half of the United States, this moisture is laden with sulphurous acids from fossil fuel burning plants to the west, natural salts such as Sodium Sulphate that were absorbed by the evaporation

of ground water or Potassium Carbonate found in fly ash in the atmosphere. As these contaminants enter into the masonry assembly, their interaction with the assembly's setting mortar have a varying degree of negative effects. The most common result of this interaction is the deterioration of the lime component of existing setting mortar. When sulphurous acid comes into contact with the lime (calcium carbonate) in mortar, the end result is a chemical compound called Calcium Sulphite ( $\text{CaSO}_3$ ). This new compound replaces the calcium carbonate in the mortar, thus reducing the mortar's strength and bonding capacities. As this compound combines with oxygen, gypsum crystals form and grow much like the sodium crystals do. However, unlike sodium crystals (which singularly exert damaging pressure) gypsum crystals expand up to 200% of their original size (creating adjacent voids in the mortar) then dissolve with the contact of additional acid rain. The actions and reactions described have caused the mortar to weaken under the pressures of material deterioration. Freeze/thaw pressures during seasonal changes aggravate the process. As the moisture slowly leaches out or its vapor migrates out of the assembly, the joint to falls because the components are no-longer one.

Mortar deterioration due to differential moisture absorption values between the clay brick masonry and the granite base.

• Conditions similar to <b>Plate #1</b> : 4 conditions total:	\$1,000.00
• Conditions similar to <b>Plate #2</b> : 4 conditions total:	\$500.00
• Conditions similar to <b>Plate #3, 7 &amp; 8</b> : 2,000 sf total:	\$36,000.00
• Conditions similar to <b>Plate #4</b> : Stitch & repoint 2 corners total:	\$3,000.00
• Conditions similar to <b>Plate #5</b> : Rebuild 40 s.f. total:	\$3,000.00
• Conditions similar to <b>Plate #6</b> : Stitch & repoint 80 s.f. total:	\$4,800.00
• Conditions similar to <b>Plate #9</b> : Stitch & repoint 2 sides total:	\$5,000.00
• Conditions similar to <b>Plate #10</b> : Install gap Filler 3 locations total:	\$4,500.00
• Roof Flashing Repairs:	\$3,500.00
• Rebuild Chimney:	<u>\$10,000.00</u>

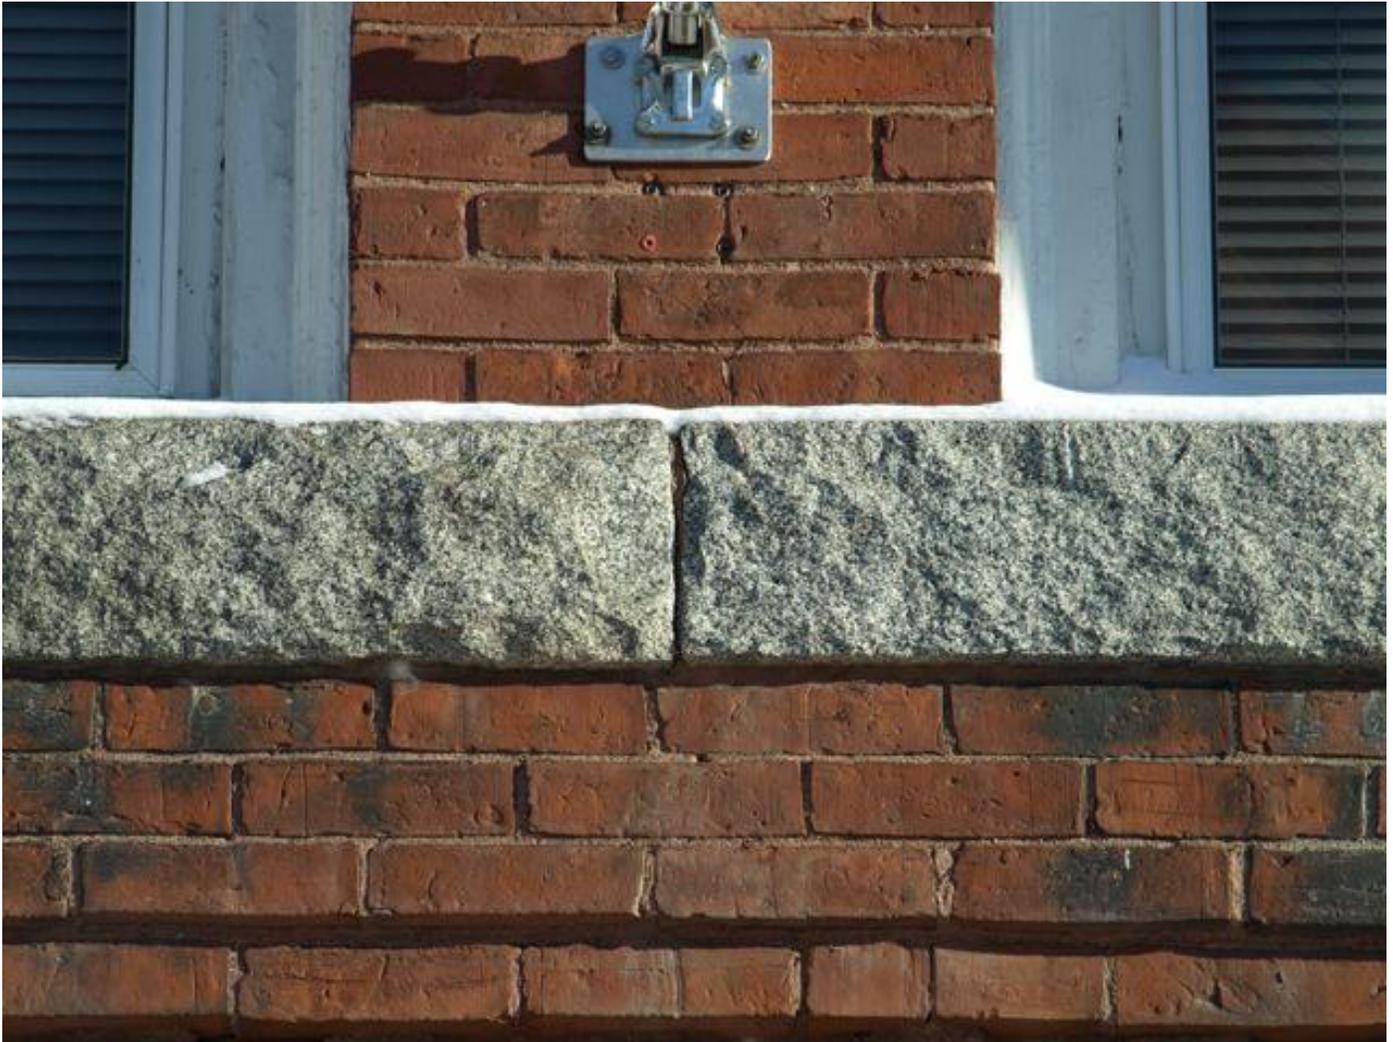
**Plate #2**

- Many mortar joints at the granite window-sills are missing or open as shown in **Plate #2**. These opening are allowing moisture to infiltrate into the brick assembly below the window units causing damage to the mortar component of the wall.

Many mortar joints at the granite window sills are missing or open.

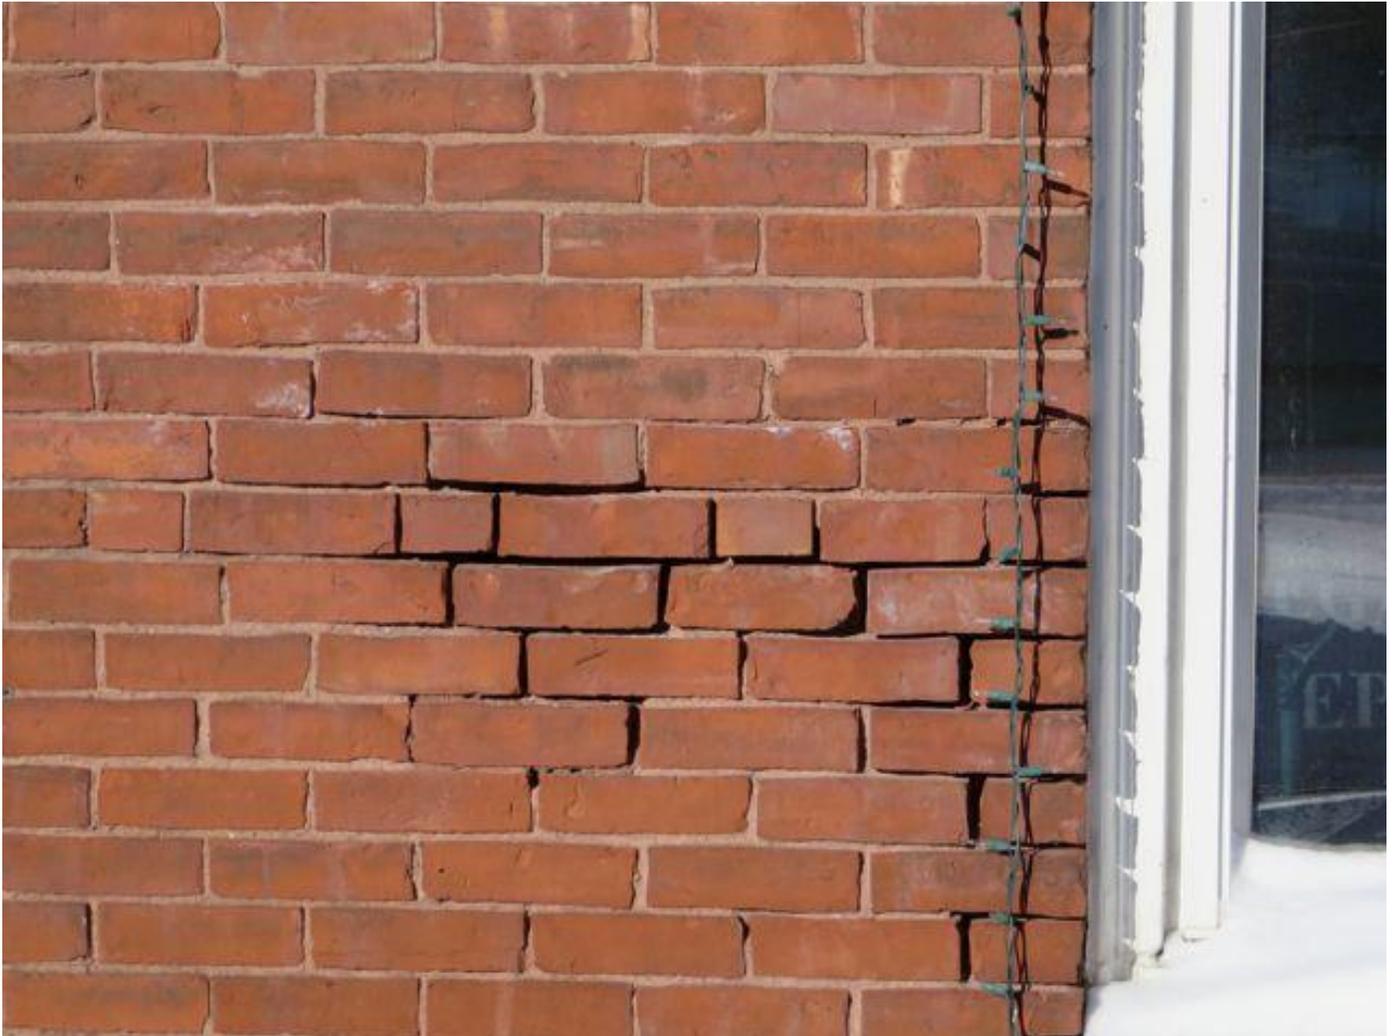
**Plate #3**

- As evidenced in **Plate #3**, some areas of mortar deterioration may be caused by heat-loss through variations in the wall assembly in and around penetrations or openings. Heated atmospheres contain a level of moisture. As the interior face of the brick assembly warms, the heat will migrate toward the exterior face of the wall. At the point in the assembly where the warm interior mass is adjacent to the cold exterior mass condensation will form. This condensation added to the inherent level of moisture within the interior space and storm related moisture infiltration from exterior sources creates a similar head of moisture as described under Plate #1. If the assembly is a given area varies in some micro fashion from adjacent assemblies, deterioration to the mortar as well as other building material may spike. This seems to be a logical explanation for this isolated damage.

Mortar deterioration may be due to differential heat loss out of the building in and around penetrations or opening.

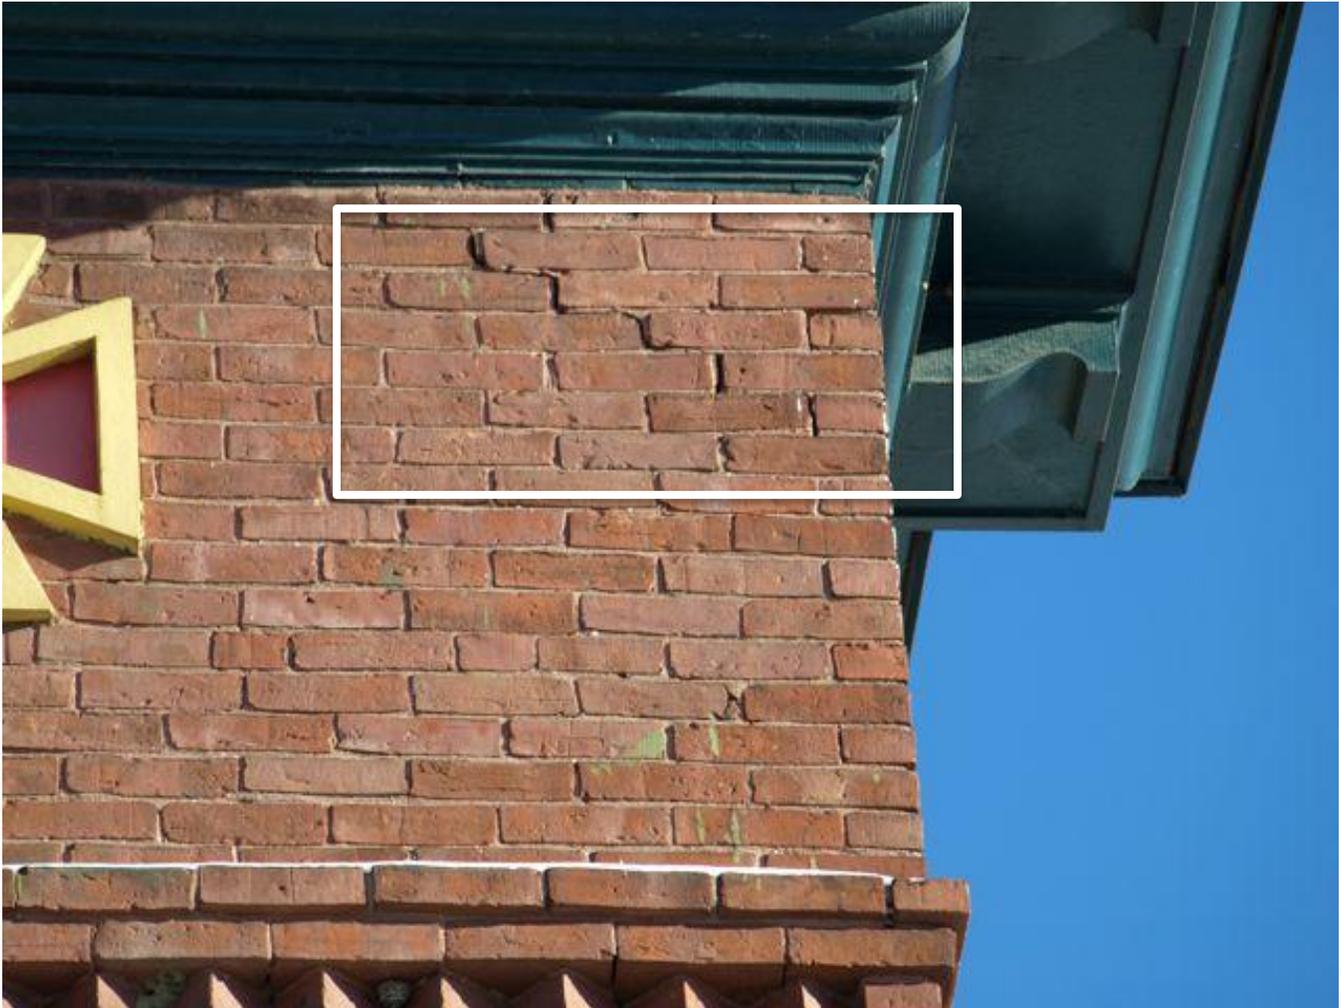
- **Plate #4** highlights an area of the masonry assembly that has fractured at the mortar joints. The wall thickness is only 2 wythes in this area. As the mortar at the collar joint ages, it shrinks and becomes unbounded to adjacent masonry. Because the collar joint is 1" wide, any shrinkage is exaggerated within the cavity, thus its evidenced by failure at the wall's weakest point...the mortar joint. This type of failure is also present at the building's diagonally opposite corner.

A fracture in the upper brick assembly is caused by the aging of the mortar within this 2 wythe wall section.

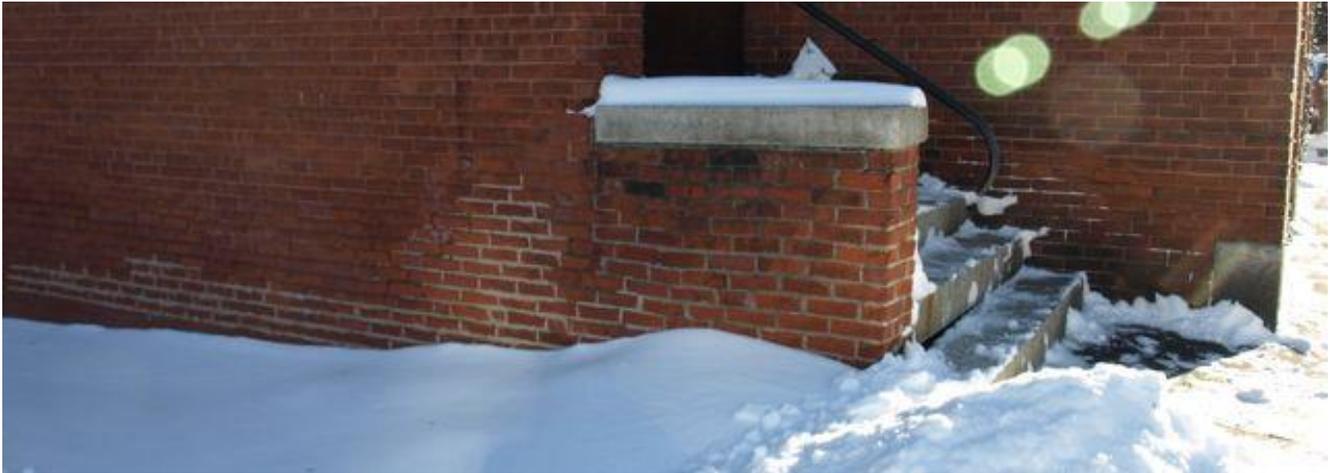
**Plate #5**

- The short knee wall at the left entrance stairs is in poor condition as evidenced in **Plate #5**. The assembly is leaning and rolled away from the plain of the building wall. Additionally, the mortar along the wall's base to the left of the knee wall is deteriorated due to the conditions outlined under Plate #1.

The short knee wall at the left exterior entrance stairs is in poor condition.

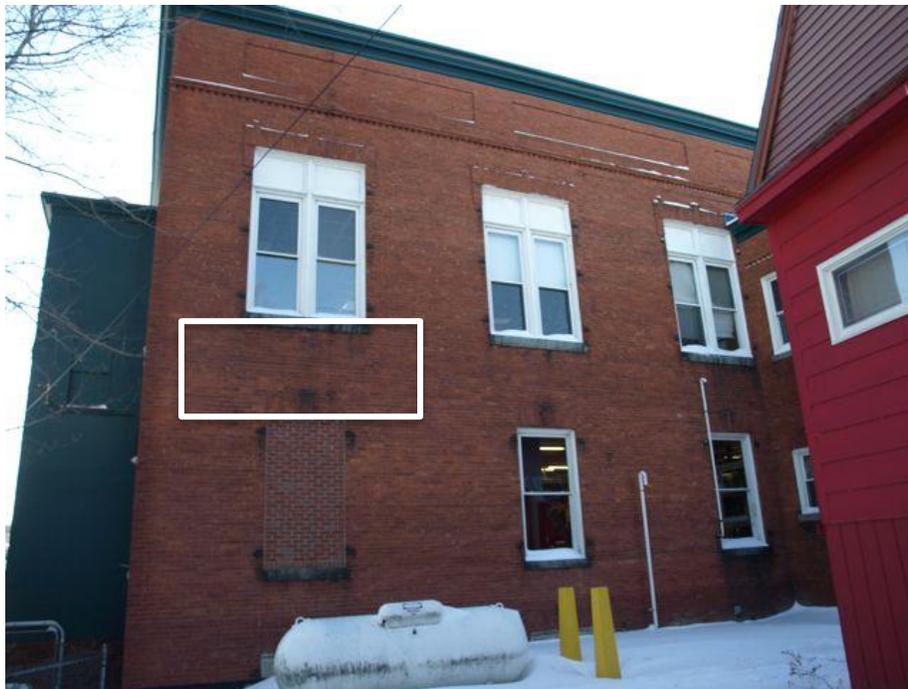
- **Plate #6** highlights area of the assembly on the building's north elevation that has fractured. This damage was caused by the expansion of the clay masonry units at the window infill. All clay brick units spend a life absorbing moisture. Units of different ages absorb moisture at different rates. The rule of thumb is the new the unit, the higher the rate of absorption. As the clay units absorb moisture, they will expand in size vertically as well as horizontally. Although this growth is slight, it does exert pressure on adjacent materials and assemblies. If this pressure cannot find relief at an expansion joint, it will find relief at the wall's weakest point. In the case of this building, this point is the aging mortar. Hence, the result is the fracture that is present within the area indicated.

The assembly within this area is fractured due to the difference of expansion values between the original masonry and the new window infill.

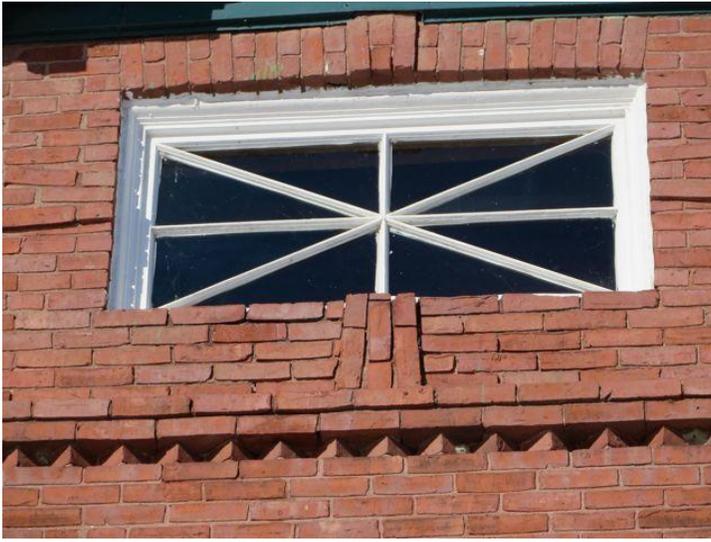
**Plate #7**

- **Plates #7 & 8** highlight areas on the building that have deteriorated pointing mortar due to the exposure of the masonry profile. Features such as belt courses, keystones and window arches that create a horizontal plain to the mortar joint profile all show deterioration.

The mortar joints within the highlighted pictures are deteriorating due to their protruding exposure from the plain of the adjacent masonry.

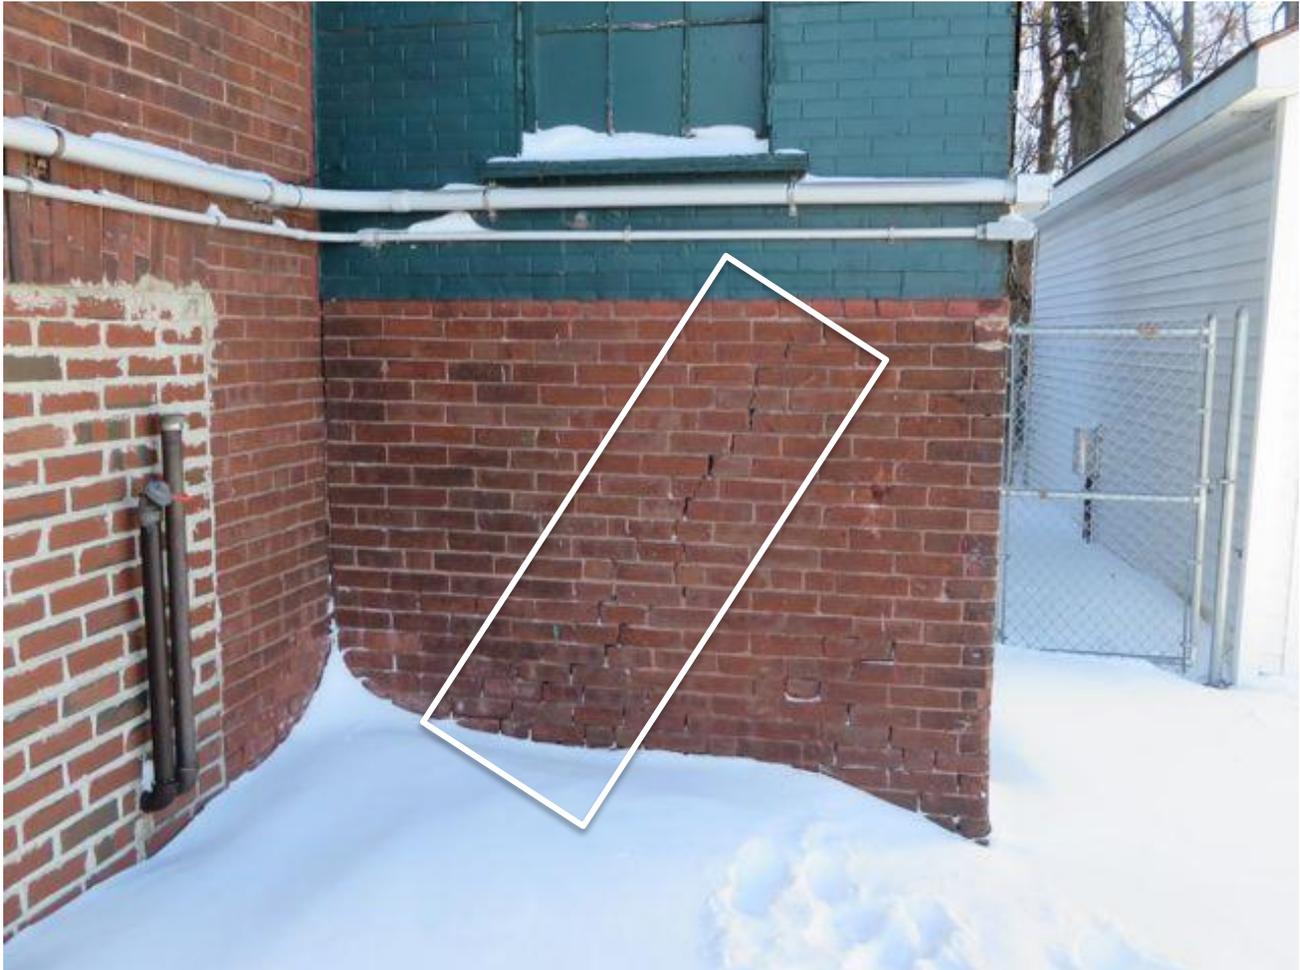
- **Plate #9** highlights an area of masonry at the base of the hose tower that has fractured. This fracture appears to be caused by moisture infiltrating into the assembly at or below grade, thus causing damage to the mortar component of the assembly and allowing the driving force for damage caused by freeze/thaw action. The exterior face pointing is in poor condition on the balance of the wall's face, thus reducing the wall's ability to impede further moisture infiltration.

The assembly within this area is fractured due to moisture infiltration at or below grade.

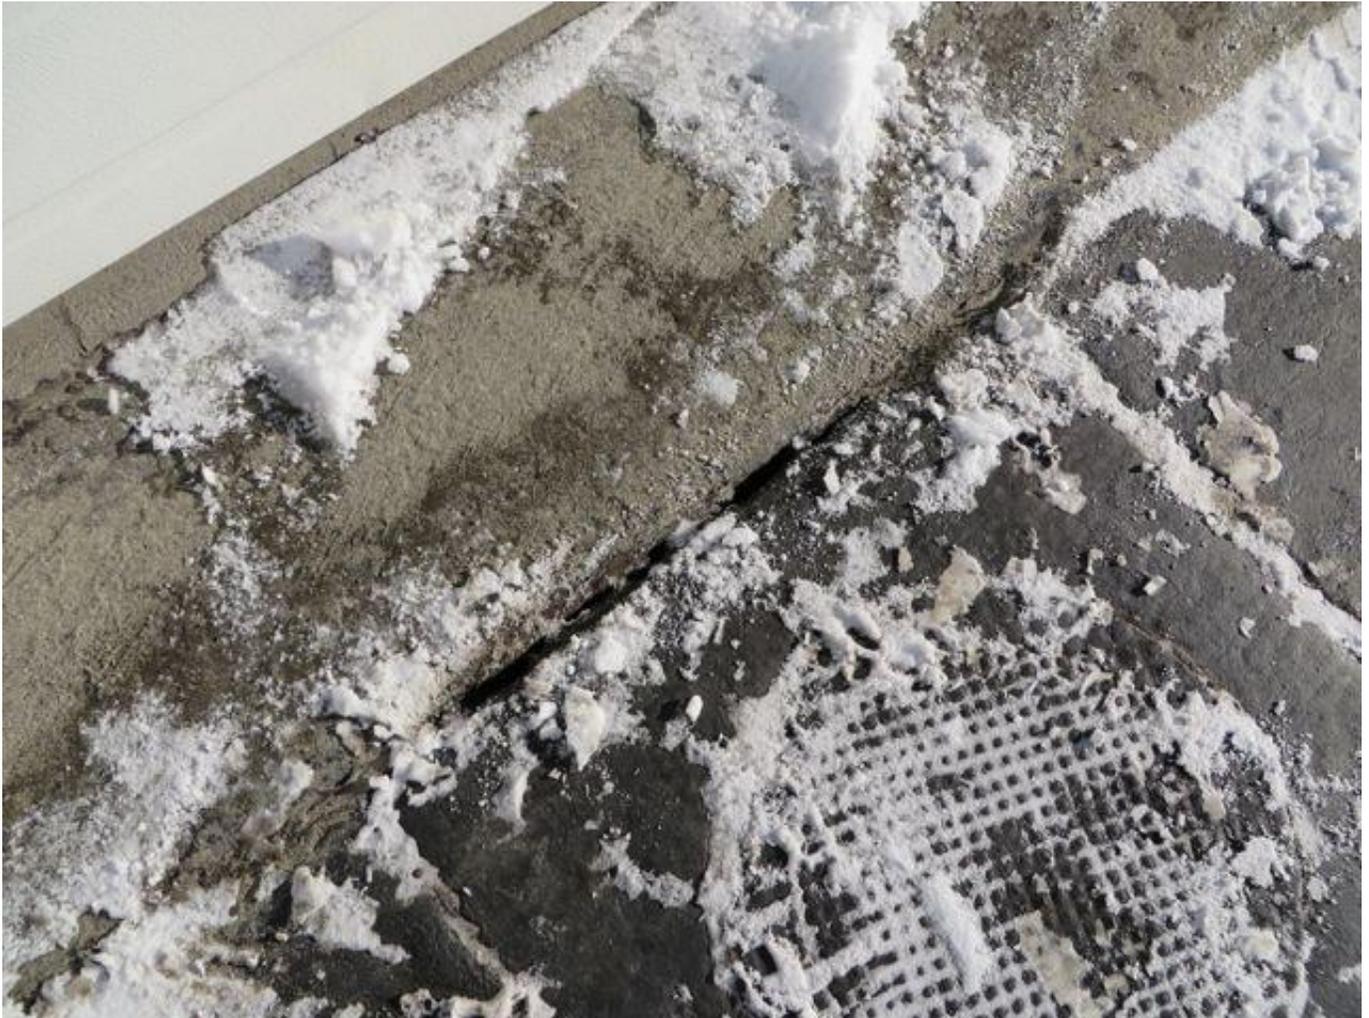
- **Plate #10** documents the gap that existing between the granite door threshold and the bituminous coating on the entrance ramp. The gap is approximately 3/8" wide and is allowing moisture to infiltration into the basement space, which is causing damage the concrete floor slab. Additionally, the **Plate #10** shows the original coal shoot cover, which there is evidence of moisture infiltrating around and through it as well.

The assembly within this area is fractured due to the difference of expansion values between the original masonry and the new window infill.
